Case Study of Detailed Settlement Analysis of an Old Residential Building within Lahore Fort, Pakistan

Abstract: This study deals with settlement analysis of a single story old residential building constructed inside the Lahore fort, Pakistan. It was constructed on non-engineering fill and it exhibited major differential settlement. The building started to exhibit cracking and was rendered unserviceable in 2009. The building has to be demolished for the new proposed structure. Crack mapping was performed to get an idea about the prevailing structural condition of the building. Precise leveling was carried out to determine the exact amount of differential settlement in various parts of the building and its surrounding area. Soil investigation was carried out to determine the depth of the non-engineering fill and any other factors that contributed to the excessive settlement of the building. The engineering properties of the associated soil samples were determined. Finite element analysis was carried out using computer aided software to suggest different foundation solutions for the site. A cost analysis was also carried out for the decided remedy.

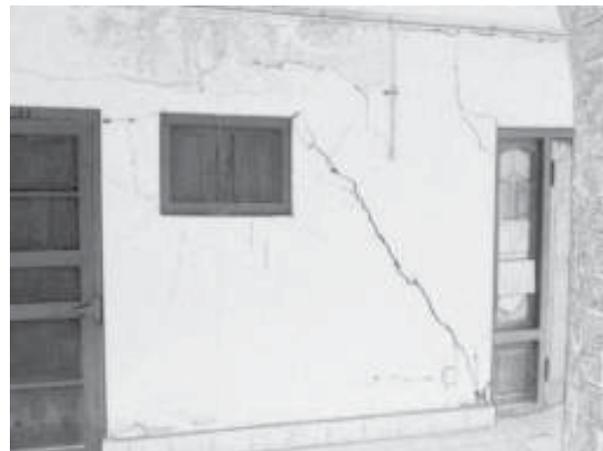
Fig. 2. View of Exterior cracks

Initially, the numerous shear cracks in walls across the building were examined and their features were noted as shown in Fig. 2 and Fig. 3. The cracks on the inside face of the walls were of greater severity as compared to those on the exterior face. The width of the cracks on the exterior side was observed as less than 25mm, whereas majority of the interior cracks easily fall within the range of 50-75mm width.

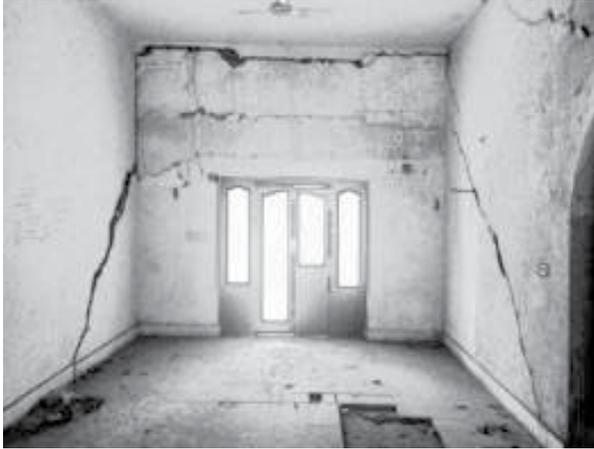
Fig. 3. View of Interior cracks

Additionally, the cracks angles were in the ranges between $45\text{-}60^\circ$. The residents of the building had erected several brick columns throughout the structure in order to prevent it from collapse or further damage. None of these columns served any structural purpose as they were not rigidly connected to the building and no loads or moments were being transferred to them from the building. Such actions of the residents only resulted in additional loads acting on the foundation. One of the columns mentioned above can be seen in Fig. 4.

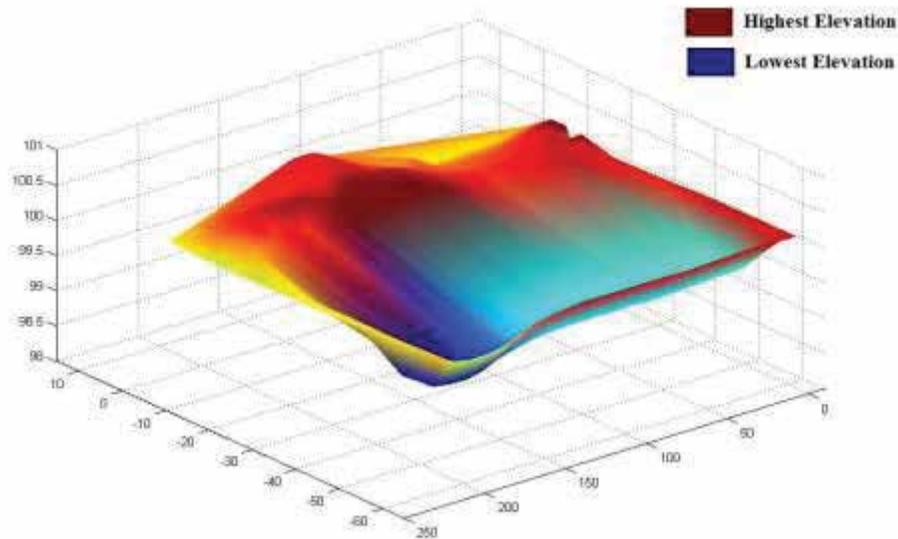
Fig. 6. 3-D Settlement model (ft)

and a fall occurs if the forward reading is greater in value than the preceding reading. These rises and falls are then added to a Reduced Level (RL). The results obtained from the leveling of the building site were then entered into MATLAB to create a 3-D model of the settlement the building, that can be seen in Fig. 6. It can be seen that the building has undergone massive differential settlement.

The results of the leveling confirmed the initial estimation of the building's settlement lying within the range of 0.3m. However, one portion in the corner of the building had undergone excessive settlement to about 0.6m. The reason for such an anomaly was discovered to be a running cracked sewer line beneath that portion. The seeping water has washed away soil particles, resulted in collapse of the soil beneath the structure. The settlement problem resulting from groundwater extraction in city of Bologna was also reported [6]

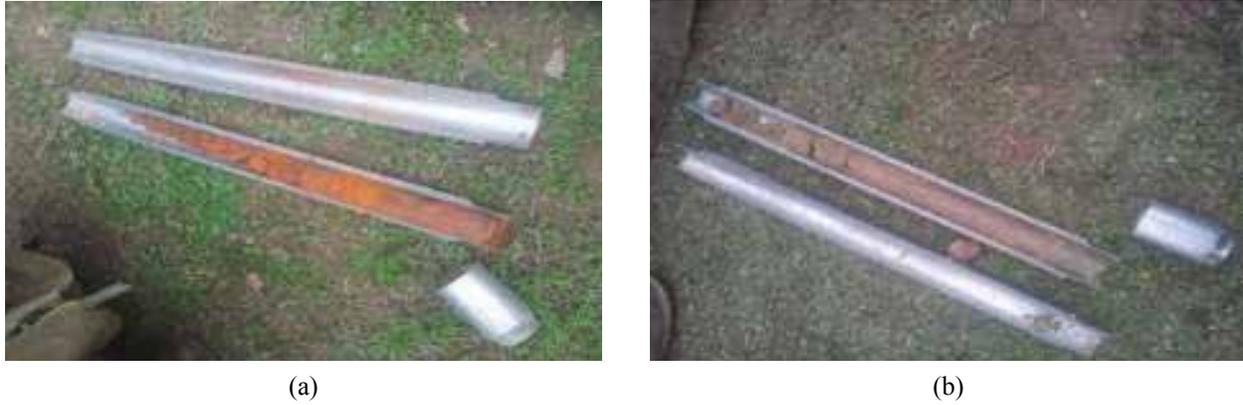
Fig. 7. Soil Sample obtained from BH-3 at (a) 1.8m and (b) 7.6m depth

be discarded as false values were obtained due to the interference of the non-engineering fill. The presence of multiple layers of brick ballast in the soil strata resulted in an outrageous number of blows. Images of the samples obtained from bore holes can be seen in Fig. 7. The borehole log of BH-3 is shown in Fig. 8.

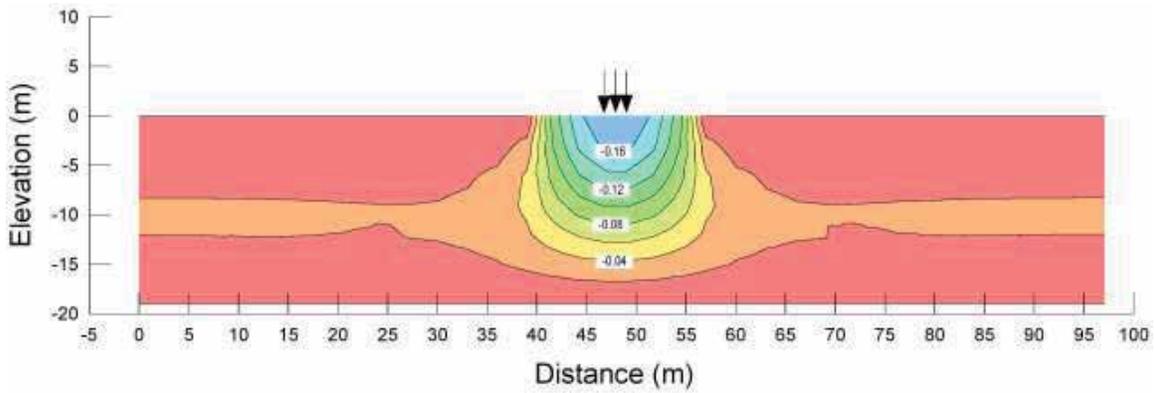
Fig. 10. Settlement analysis for existing soil beneath building

The finite element analysis was carried out on GeoStudio. The non-engineering fill was a heterogeneous material and the soil properties were not evenly distributed throughout it. Therefore, the average of the determined soil parameters were used. The empirical relations based on modulus elasticity were used for determination of unknown parameters. Linear Elastic model is used to model the soil behavior. The parameters used for analysis of original soil consist of $C = 0$, $\phi = 30^\circ$, $\gamma = 14 \text{ kN/m}^3$ and Elastic Modulus = 5MPa. The simulations were run on the software to recreate the settlement in the range of what the building had undergone. For a building load of 25kPa, a settlement of 180mm was produced when an elastic modulus of 5MPa was used. The details of the settlement analysis can be seen in Fig. 10.
