Case Study of Detailed Settlement Analysis of an Old Residential Building within Lahore Fort, Pakistan

Abstract: This study deals with settlement analysis of a single story old residential building constructed inside the Lahore fort, Pakistan. It was constructed on non-engineering fill and it exhibited major differential settlement. The building started to exhibit cracking and was rendered unserviceable in 2009. The building has to be demolished for the new proposed structure. Crack mapping was performed to get an idea about the prevailing structural condition of the building. Precise leveling was carried out to determine the exact amount of differential settlement in various parts of the building and its surrounding area. Soil investigation was carried out to determine the depth of the non-engineering fill and any other factors that contributed to the excessive settlement of the building. The engineering properties of the associated soil samples were determined. Finite element analysis was carried out using computer aided software to suggest different foundation solutions for the site. A cost analysis was also carried out for the decided remedy.

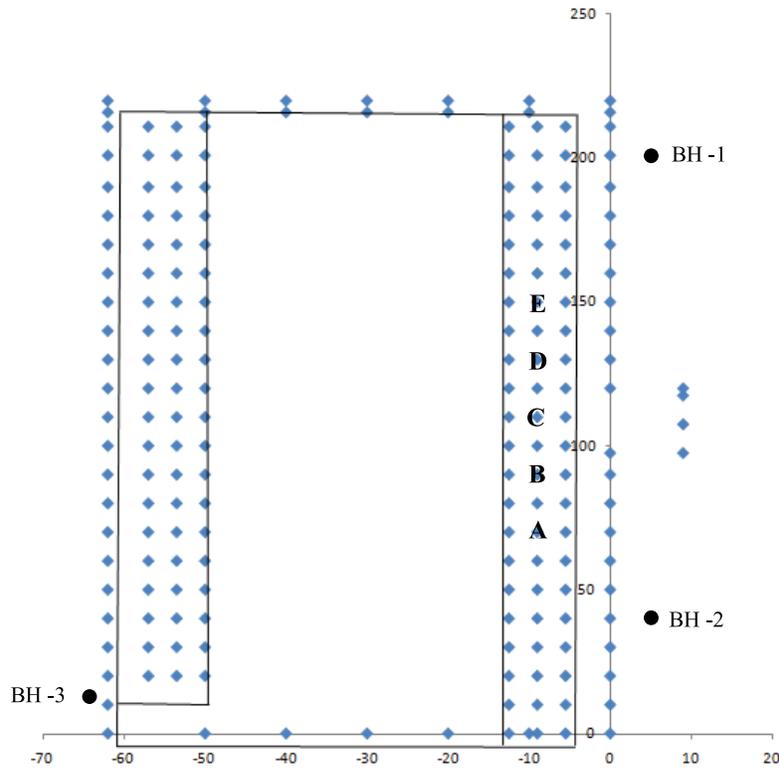
Fig. 5. Surveying grid (ft) showing location of Bore Holes (BH)

Leveling was performed on the site throughout a grid comprising of nearly two hundred points, as shown in Fig. 5. The precise leveling staff offers a least count of 0.1mm in comparison to the 5mm least count of an ordinary leveling staff. Therefore, it was intended to perform precise leveling throughout the grid in order to obtain more accurate results. Unfortunately, the ceiling height of the roofed porches, also known as verandas, on both sides of the building was 2.5m, which was not sufficient enough for the 3m precise leveling staff to be vertically fit. Due to this limitation in the equipment, precise leveling was only performed on the exterior perimeter of the building, while ordinary leveling was done in the verandas.

The results of the leveling confirmed the initial estimation of the building's settlement lying within the range of 0.3m. However, one portion in the corner of the building had undergone excessive settlement to about 0.6m. The reason for such an anomaly was discovered to be a running cracked sewer line beneath that portion. The seeping water has washed away soil particles, resulted in collapse of the soil beneath the structure. The settlement problem resulting from groundwater extraction in city of Bologna was also reported [6]

Three boreholes were drilled at selective areas. The first hole was drilled in area having noticeable

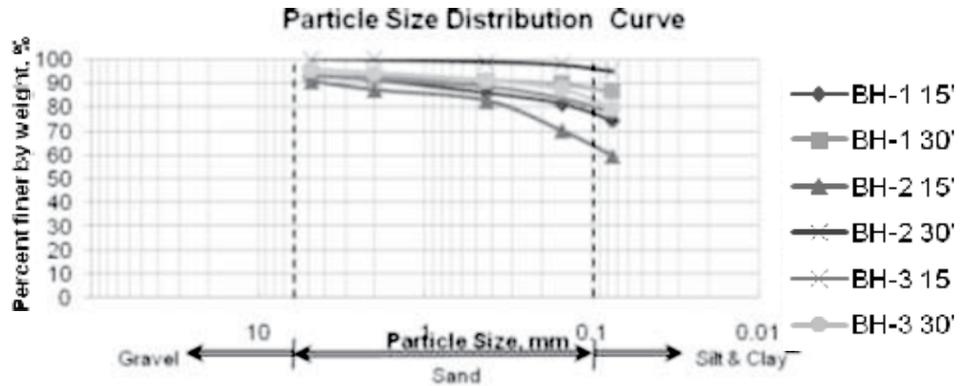
The soil samples obtained from the boreholes were taken to the laboratory for testing. From each borehole, samples were used from the depths of 4.5m and 9.0m. The soil samples taken to the laboratory were pulverized, dried and then placed in separate containers for the different types of testing, such as particle size analysis, Atterburg limits [10], shear strength parameters. First of all, each of the soil samples was put through sieve analysis to ascertain the particle size distribution. This was carried out according to ASTM procedure [9] as shown in Fig. 9. The Atterburg limits [10] of the soil (the Liquid Limits and Plastic Limits) of the soil were measured using ASTM- D4381 method and samples are given in Table 1. Increasing trend with depth was in general observed in laboratory estimated values for liquid limit, plastic limit and plasticity index. The collected soil samples were classified in accordance with the [11] specifications and are shown in Table 2. The soil samples are mostly classified as low plastic clay and silty sand.

Fig. 9. Sieve analysis of soil samples recovered from boreholes (ASTM-D422-63 method)

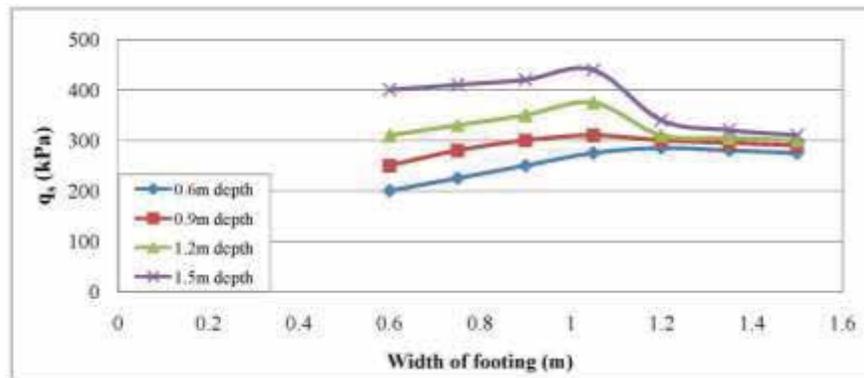
Fig. 13. Bearing capacity curves for soil

future construction. The (MRS) market rate systems rates [13] were used to evaluate the economically viable solution (and 1USD = 100PKR). The most economical solution (Table 4) would be to replace the soil beneath its zone of influence having more suitable properties. It would be suitable to use A-3 [14] soil with the properties of $C = 0$, $\phi = 33^\circ$, $\gamma = 16 \text{ kN/m}^3$, Elastic Modulus = 8MPa, Permeability = 10^{-5} m/s . The replaced soil should be compacted to 95% according to [15] specifications. The depth of replacement was decided by using GeoStudio, by replacing depths in trial and error until the settlement produced was within an acceptable range of 25mm. In the end, a settlement of 25mm was achieved with soil replacement of 6m as shown in Fig. 11. Building has undergone differential settlement. The settlement analysis considering the affect of 5 footings is shown in Fig. 12 and results are compared with actual measured settlement in Table 5. The difference in result is due to hydrogeneity of the problem. Furthermore, detailed manual calculations were also done for development of bearing capacity curves with regards to both shear and settlement [17]. The influence zone of each footing was taken to be four times its width. The

bearing capacity curves are given in Fig. 13.
